COMPREHENSIVE ANALYTICAL RESULTS REPORT CEMENT CREEK WATERSHED (CERCLIS ID # CO0001411347)

SAN JUAN COUNTY, COLORADO

SITE INSPECTION

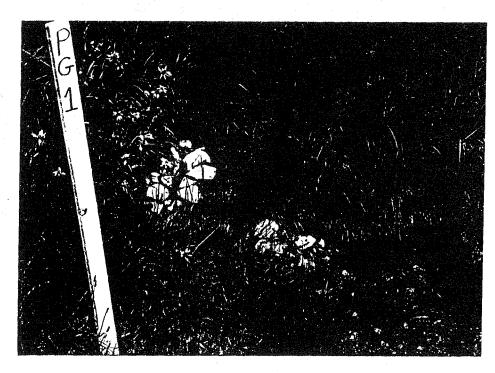
Description of Photo: PG-SE-01 Prospect Gulch upstream of the Galena Queen Mine.

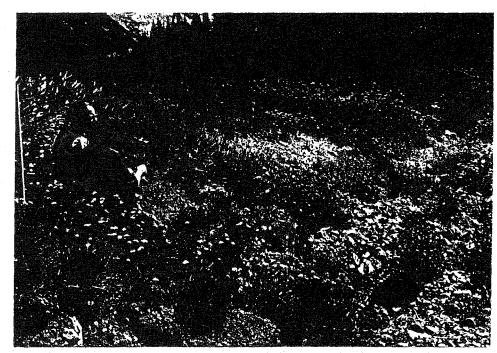
Description of Photo: PG-SE-04 Tributary to Prospect Gulch.

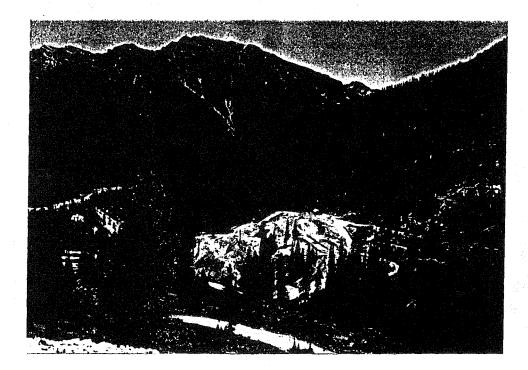
Description of Photo: PG-SO-04 Henrietta 7 Mine waste pile.

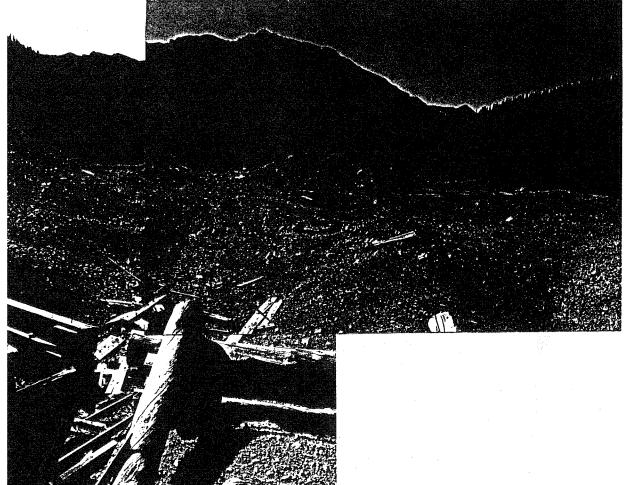
Description of Photo: PG-SO-05 Lark Mine drainage flow path.

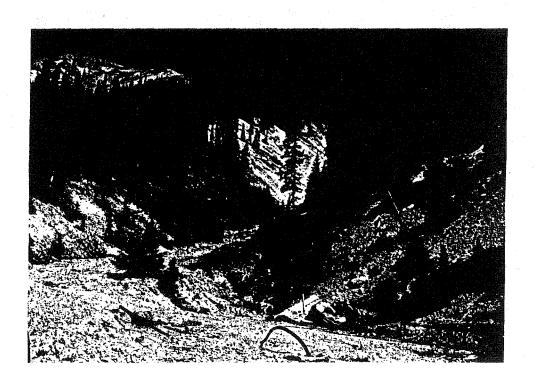
Description of Photo: PG-SO-07 Joe and John's Mine adit.
